Eliminating Oil Leaks

by optimizing Bearing Case Oil Labyrinths

Presented and published in the proceedings of the 27th Turbomachinery Symposium, September 22-24, 1998, Turbomachinery laboratories, Mechanical Engineering Department, Texas A&M University, College Station, Texas

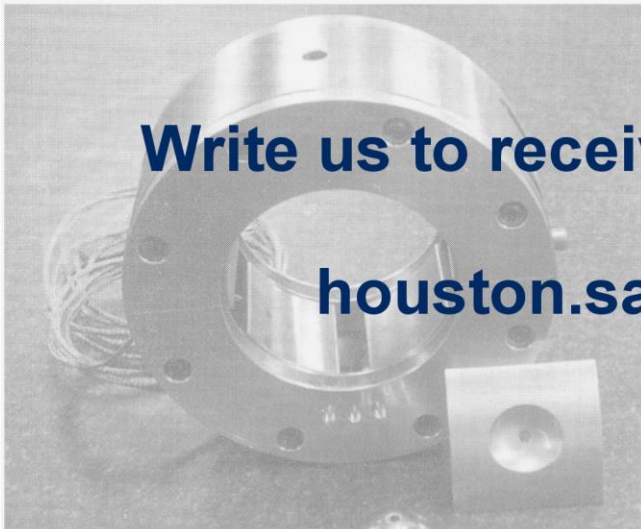
FIGURE 3 – Photograph of a Tilting Pad Journal Bearing Illustrating the Use of Labyrinth Type End Seals

Tilt pad journal bearings could also contribute to the problem. Is the bearing orificed or is the oil supply line supposed to have the orifice? The oil supply methodology of the bearing is an area that should be investigated. It is also good to know the oil pressures and orifice sizes in order to have complete records on the machine. Tilt pad bearings also usually have end seals to help control bearing oil flow through the bearing. They act as an orifice in series with the supply orifice, much the same way the v-notch works with the sleeve bearing. But they also capture the oil as it exits the bearing, directing it down toward the bearing case drain. Does the bearing have a sound design for this end seal? A two-toothed labyrinth design (**FIGURE 3**) is good, in that the oil is encouraged to collect in the trough between the lands and drain to the bottom of the seal, which has drain holes allowing the oil to drain down to the sump. Also, floating end seals combined with outer shells that drain out the top into a channel that
